Infrared Inspection Report

David A. Andersen & Associates

INSPECTION ADDRESS: [REDACTED]

DATE OF INSPECTION: 1 February 2008
 TIME: 9:30 a.m.
 SQUARE FOOTAGE: sf. (per listing)
 YEAR BUILT: 1998
 ORIENTATION TO FRONT: South.

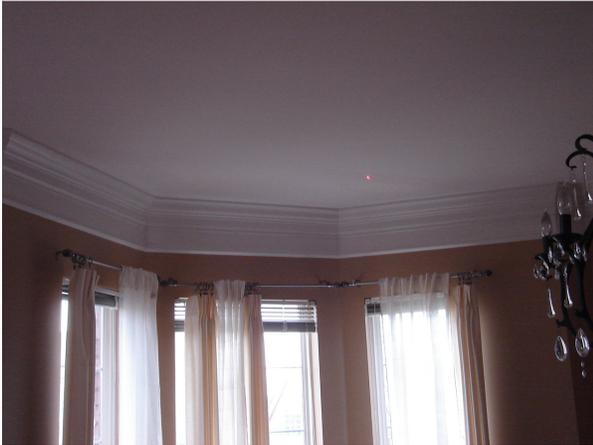
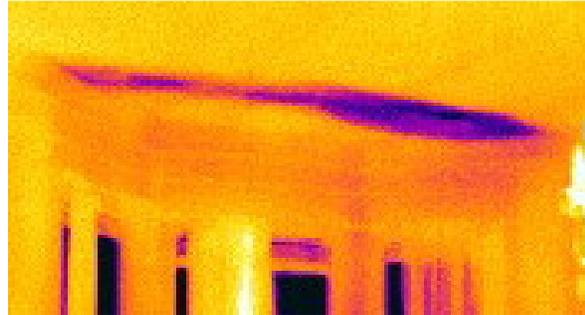
Location: Right bay window in the dining room area on the first floor.

Thermal patterns were noted. Electronic moisture testing indicated a 90% relative humidity reading in two small centralized areas of the large anomaly. The remainder of the area had substantially lower humidity readings. Location of nearby HVAC supply air registers are likely dehumidifying the moisture intrusion.

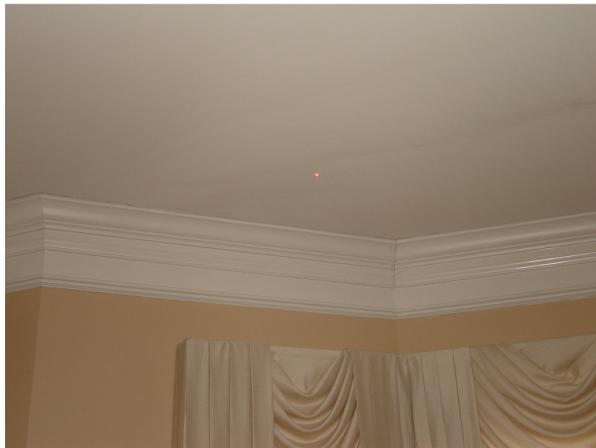
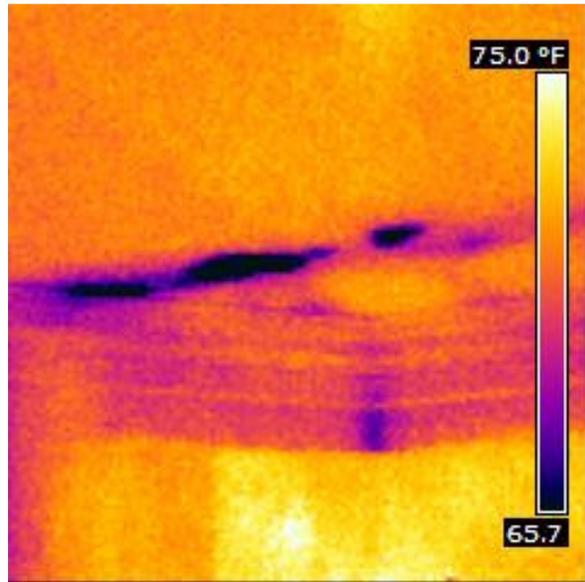
Left bay window in the living room area. First floor.

Thermal patterns were noted. Electronic moisture testing indicated a moderate relative humidity reading in the centralized area of the thermal anomaly. The location in pattern is similar to the dining room a window location.

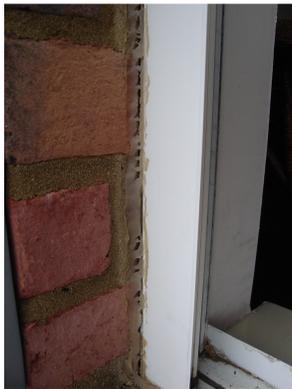
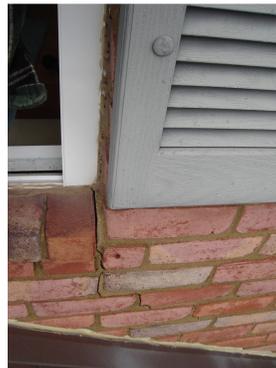
The source of moisture intrusion was located at the second-floor bedroom windows at inadequate caulking between the window in the brick veneer siding as well as a brick veneer crack radiating from the lower right-hand corner of the second-floor right window (facing the house).

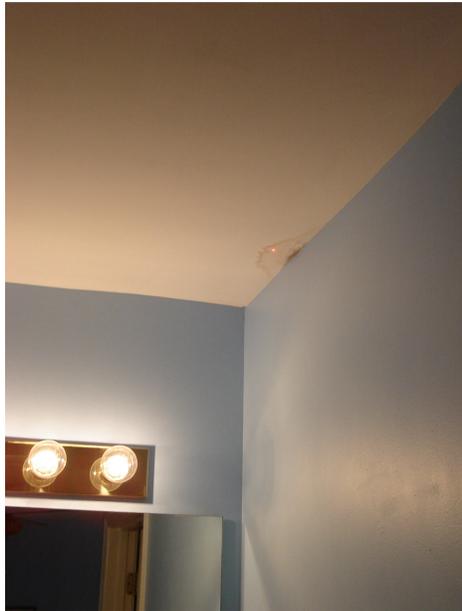
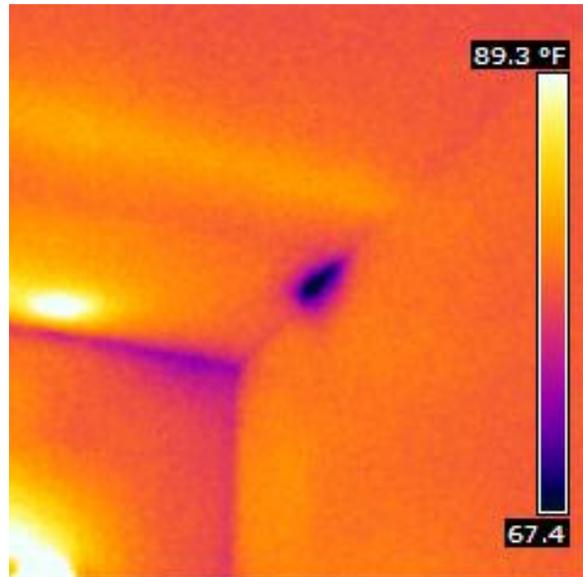
Location: Second-floor right rear bedroom and commonly shared bathroom.

Comments: A small water stain with apparent organic growth was visible at the ceiling in the right rear bedroom adjacent to the bathroom entry door. Thermal imaging indicated a substantial temperature differential. Electronic moisture testing indicated elevated moisture levels.

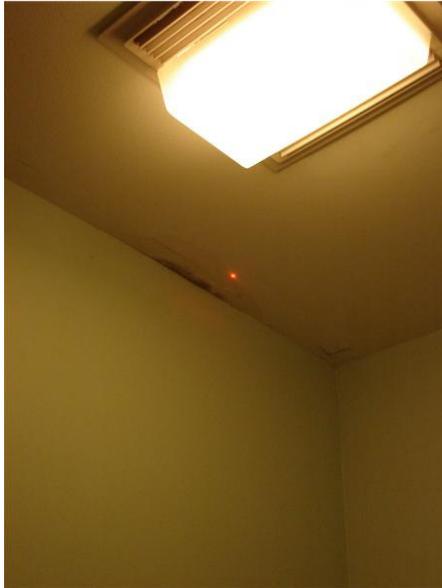
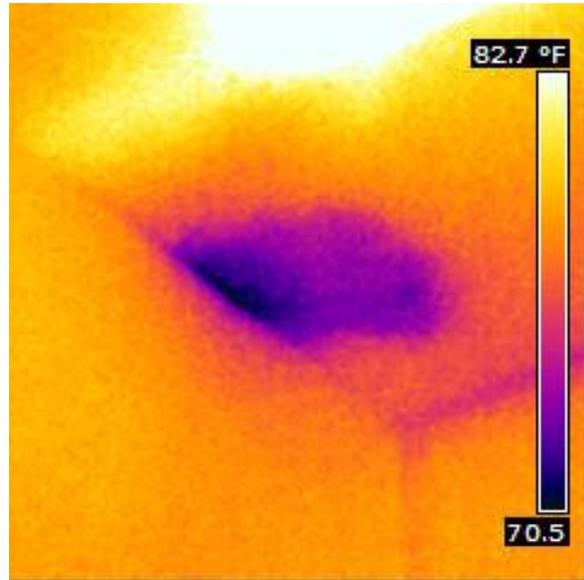
Location: Adjacent bathroom to the second-floor right rear bedroom.

Comments: A larger area of staining was located on the opposite side of a wall, immediately adjacent to the staining in the bedroom. Thermal imaging indicated temperature differentials beyond the area of staining.

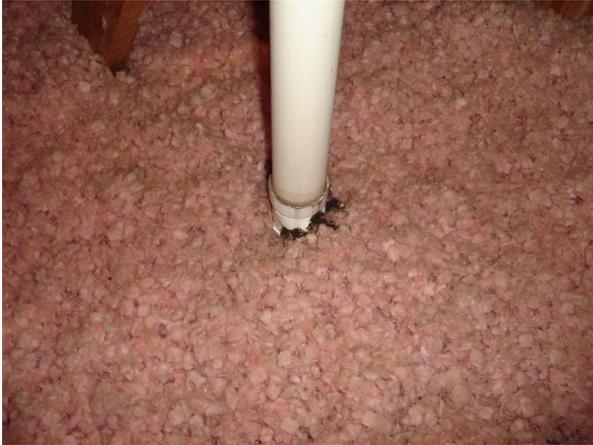
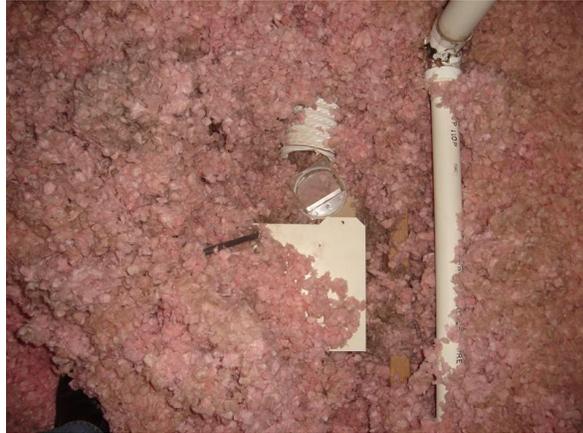
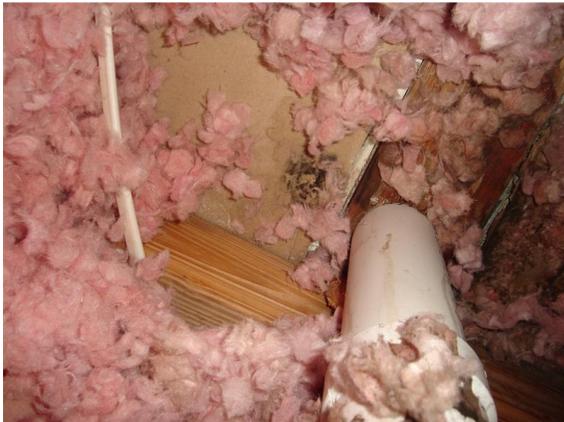
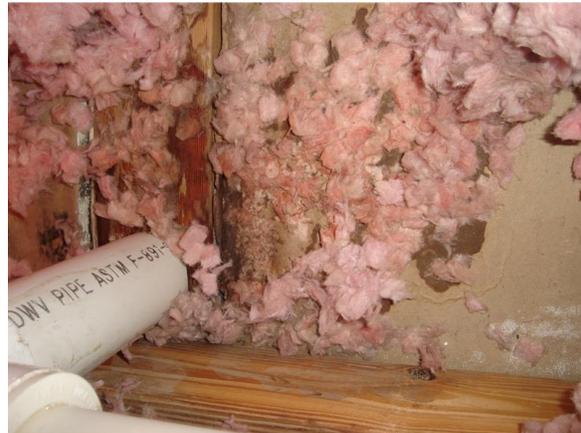
Location: Attic access.

Comments: Inspection of the attic space above the bathroom/bedroom staining disclosed a sewer vent stack passing through the wall. There was apparent organic substance on the PVC pipe at the insulation level. Removal of the insulation disclosed a detached bathroom ventilator fan duct. An area of wet and stained framing material was evident below and adjacent to the sewer vent stack. It appeared there was no leakage of the vent stack. Condensation of the moist air being discharged from the bathroom vent on to the colder vent stack piping is the suspected cause of moisture damage.

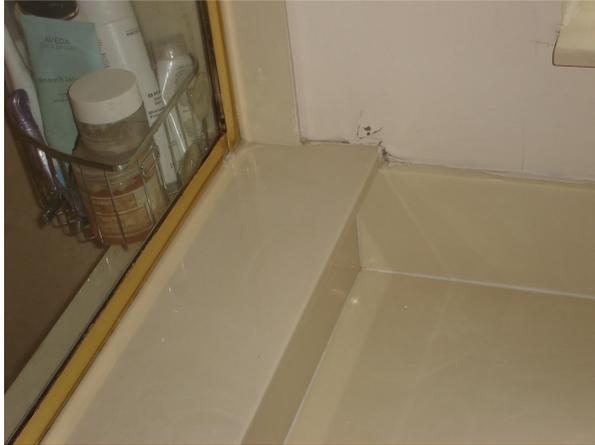
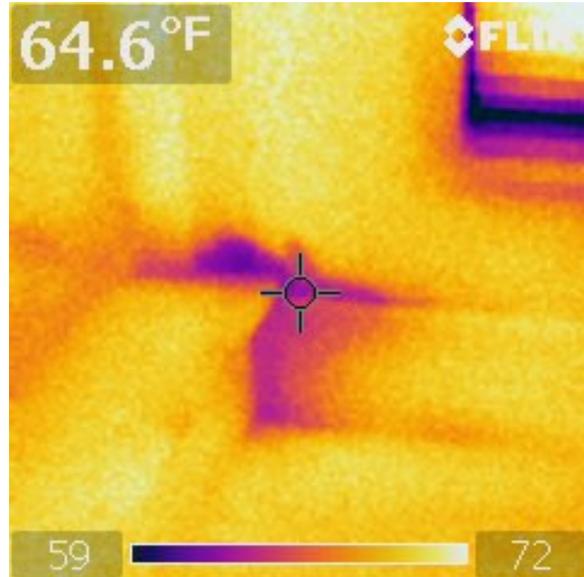
Location: Master bathroom Whirlpool tub.

Comments: There is water damage at the wall adjacent to the master Whirlpool tub. Electronic moisture testing indicated 100% relative humidity. Thermal imaging indicates the extent of this damage.

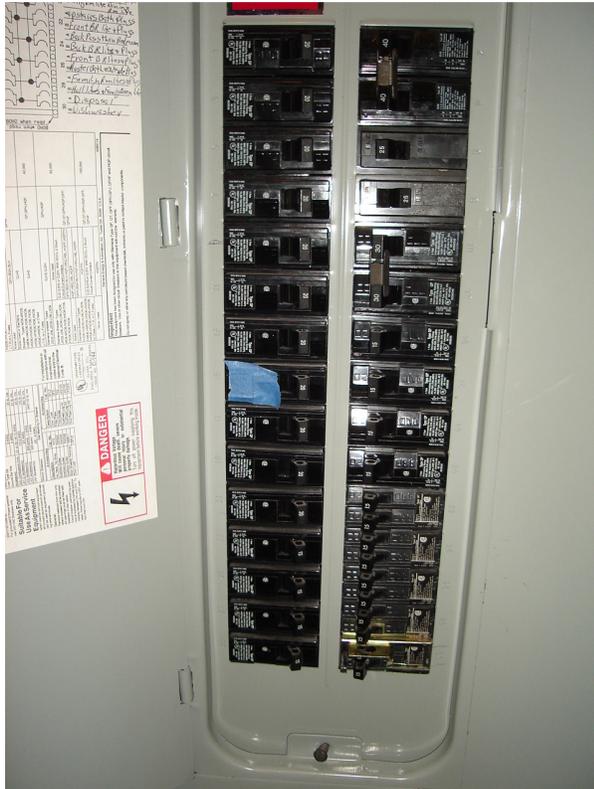
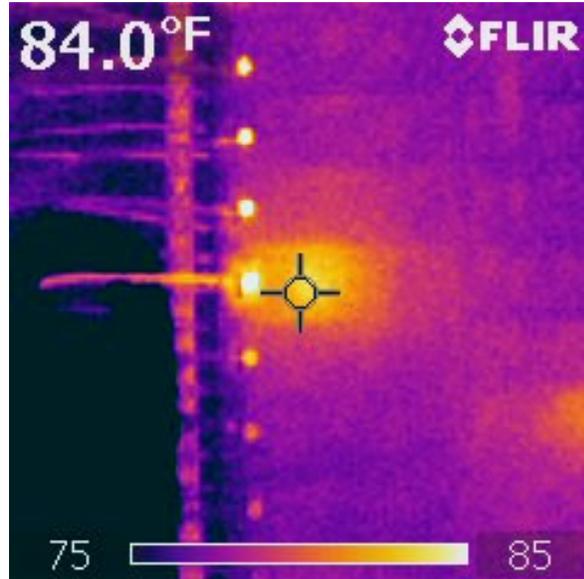
Location: Electrical subpanels in the utility room.

Comments: The eighth circuit breaker down on the left in the electric subpanel in utility room was excessively warm for the existing load on the circuit. The circuit breaker has a 20 amp capacity. The existing load on the circuit at the time of the inspection was only 8 amps. Infrared imaging indicates a possible inadequate connection at the circuit breaker/conductor terminal connection.
